NAVAL AIR PROPULSION TEST CENTER

NAPTC-AED-1869

ROTOR BURST PROTECTION PROGRAM
INITIAL TEST RESULTS

PHASE IV - FINAL REPORT
PROBLEM ASSIGNMENT NASA DPR R-105

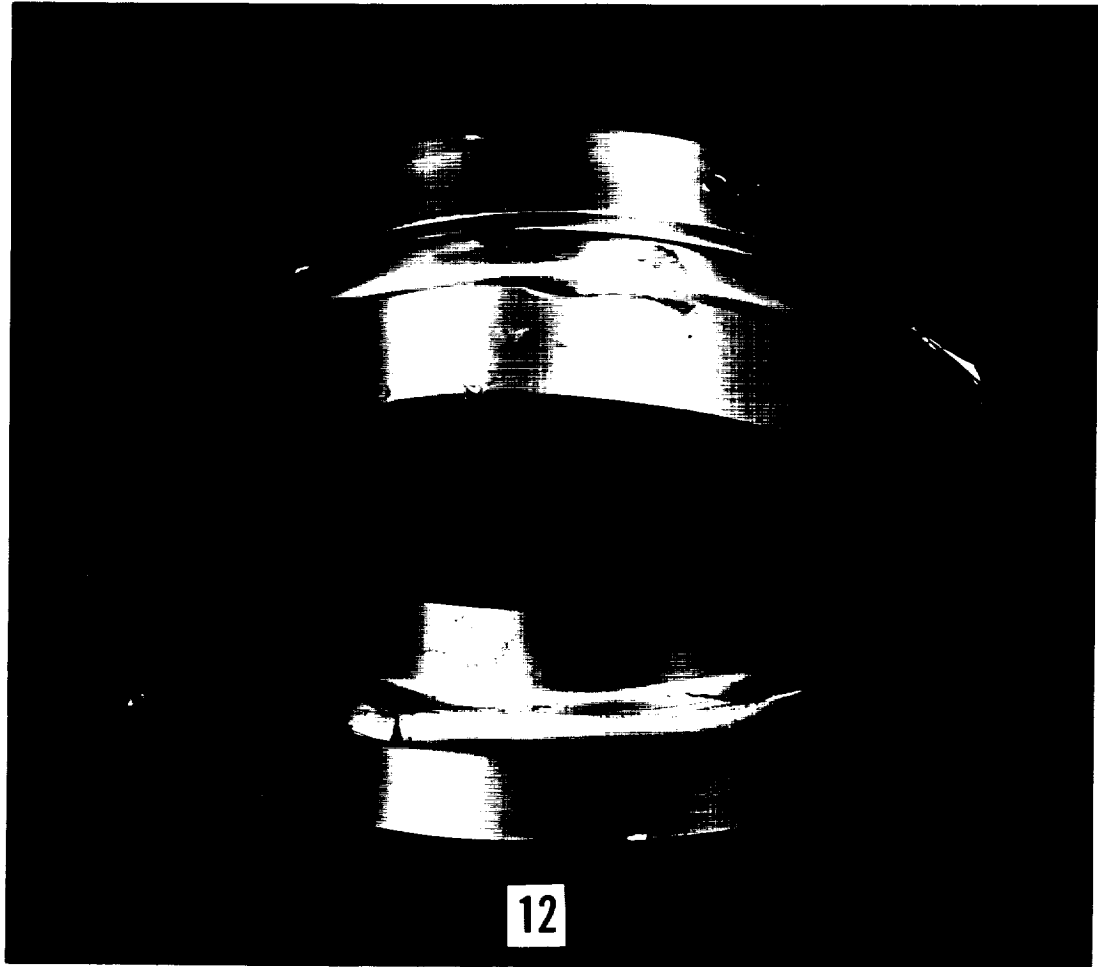
POST-TEST NO. 12 CONTAINMENT RING
BULGED-OUT CENTER SECTION

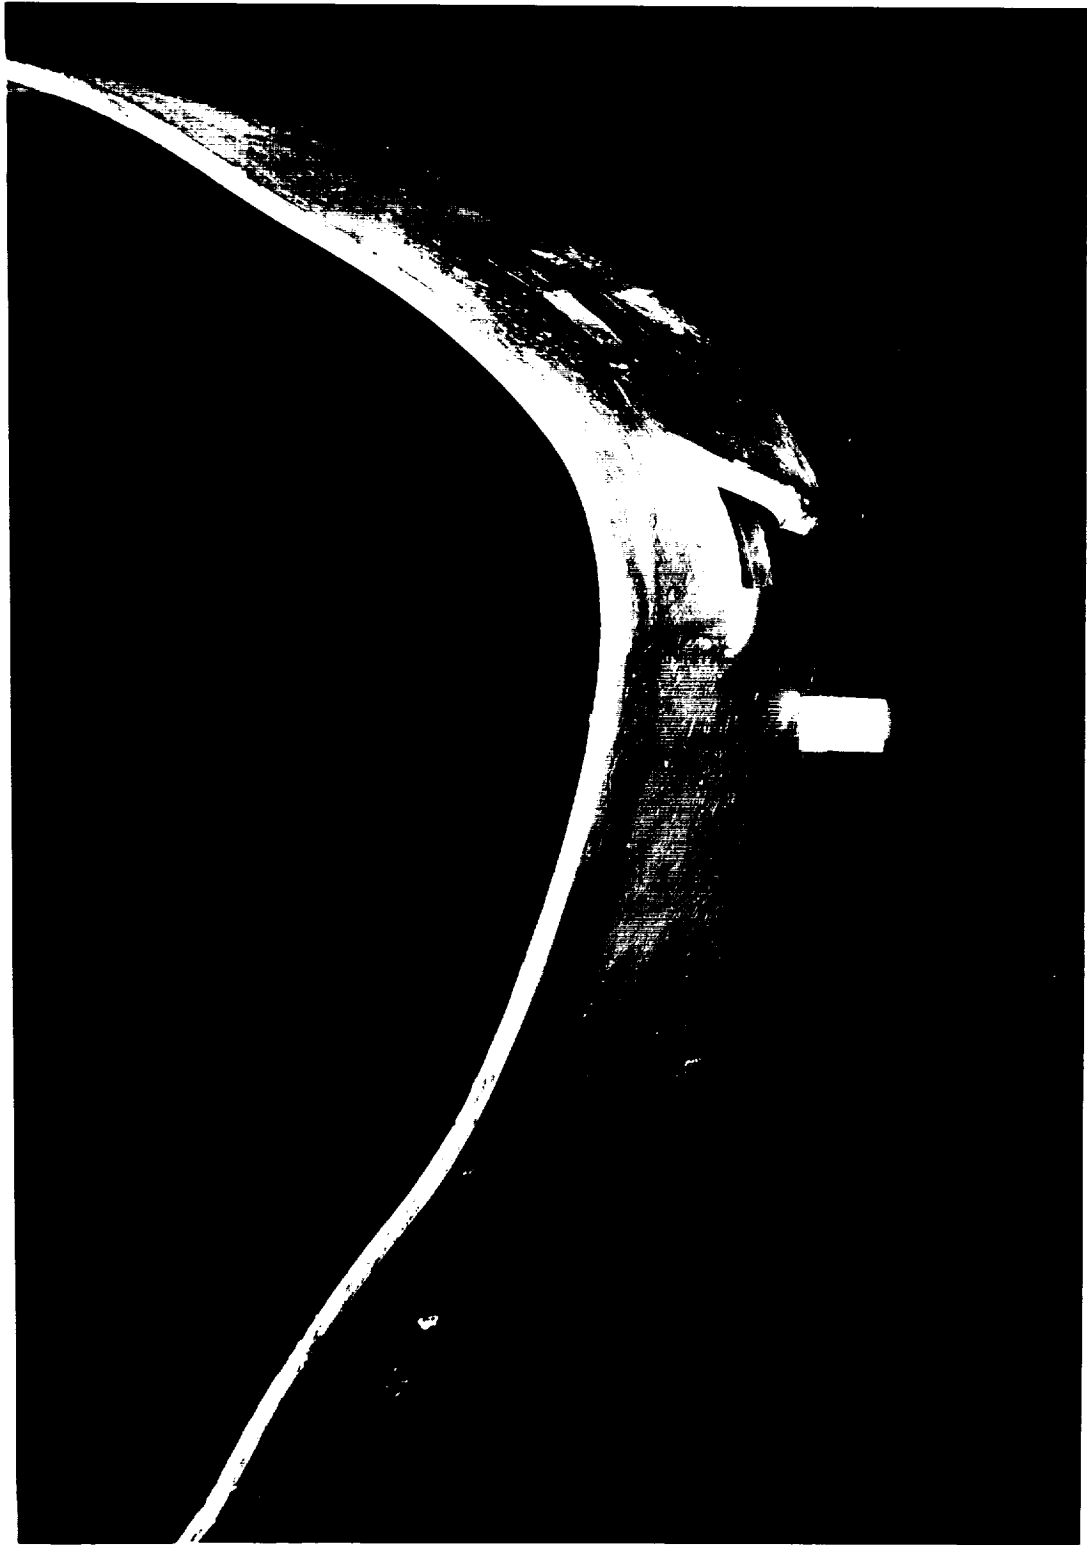
PLATE 45

87. A similar tri-hub burst was produced at a slightly higher speed than test No. 6 (13800 rpm vs. 12750 rpm). The containment ring for test No. 5 was 0.024 inches (0.252 vs. 0.228) thicker than the ring for test No. 6. The three annular sector fragments from test No. 5 apparently struck the ring simultaneously and at points equidistant around the inner circumference (plate 44). Two of the fragments left imprints in the ring but did not crack or penetrate the ring. The third fragment partially sheared a plug from the ring. Plate 45 details this plugged section still attached to the ring. This plugging action is very similar to that produced by fragment C of test No. 6.

POST-TEST NO.5 CONTAINMENT RING
PERFORATED AREA

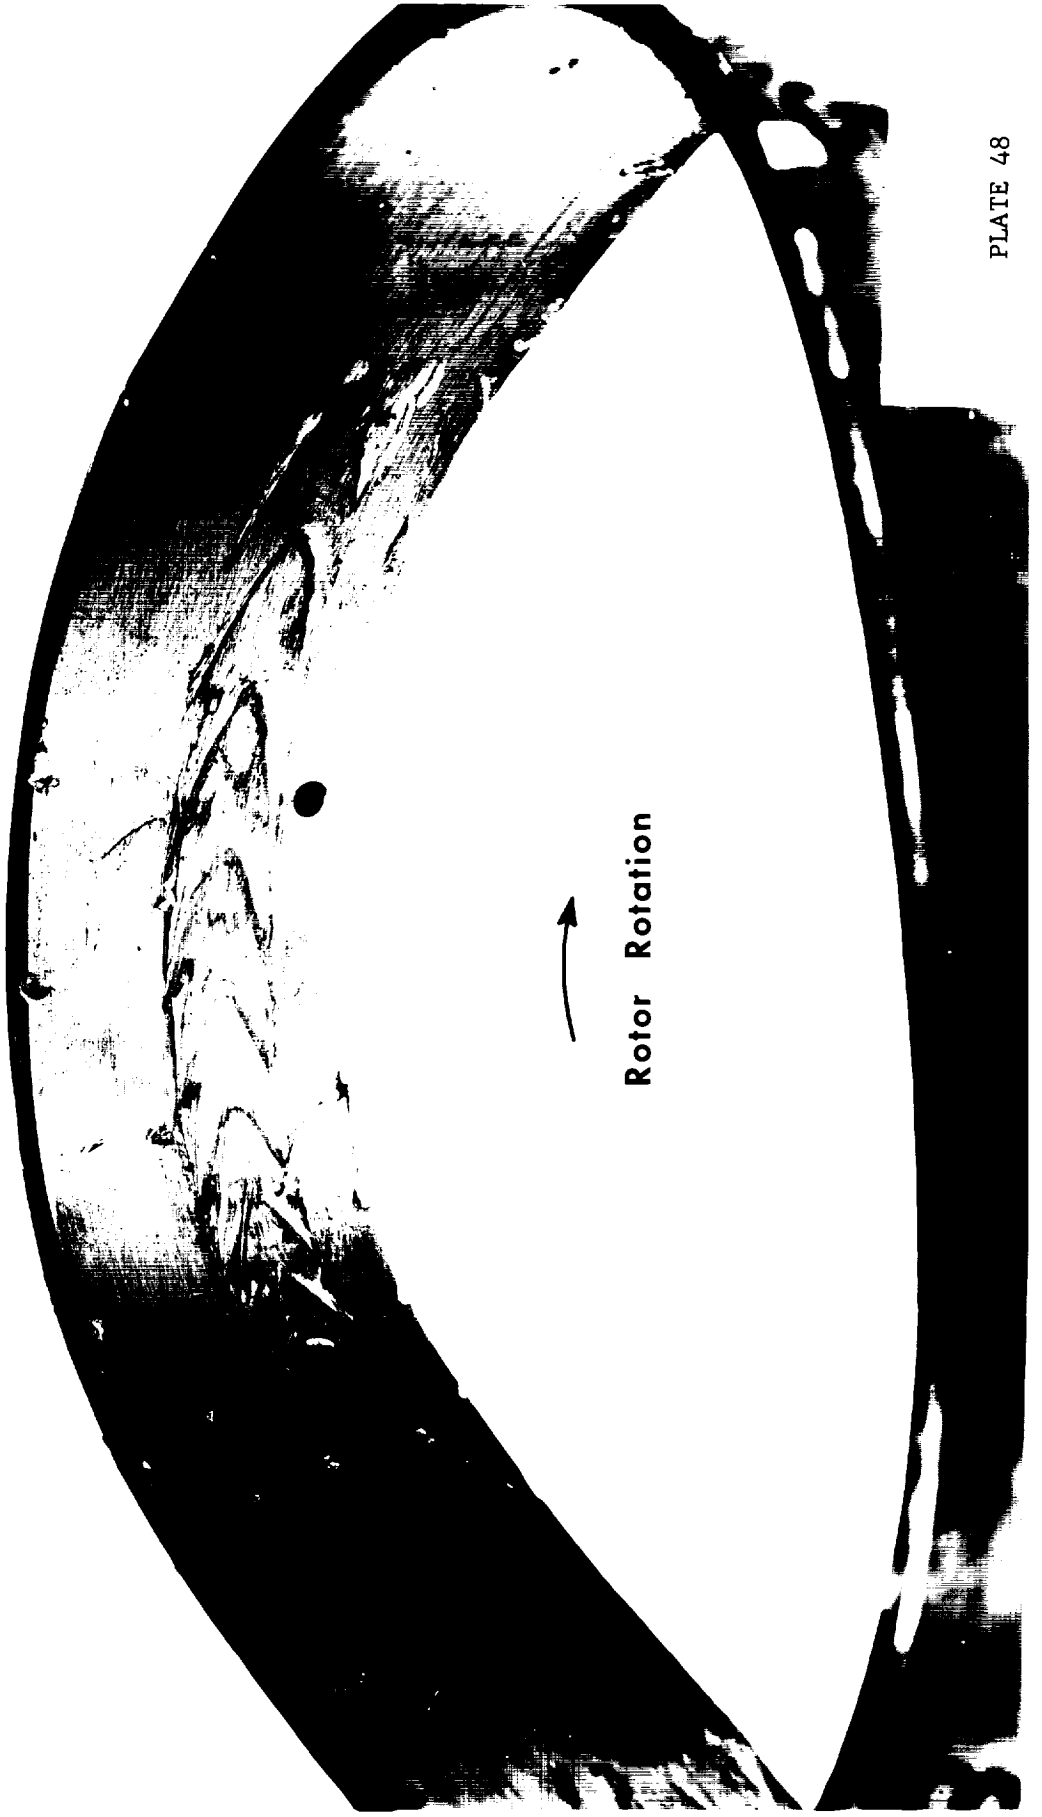
PLATE 48

91. The post-test photograph of the containment ring of test No. 20 (plate 47) is very similar to that of the No. 5 test ring. Plate 48 records one of the three areas of the inside of ring No. 20 showing the indentation of the bladed edge of the rotor fragment. This marking indicates the fragments remained in one area relative to the ring distortion.

POST-TEST NO. 20
FRAGMENT INDENTATION OF INSIDE
SURFACE OF CONTAINMENT RING

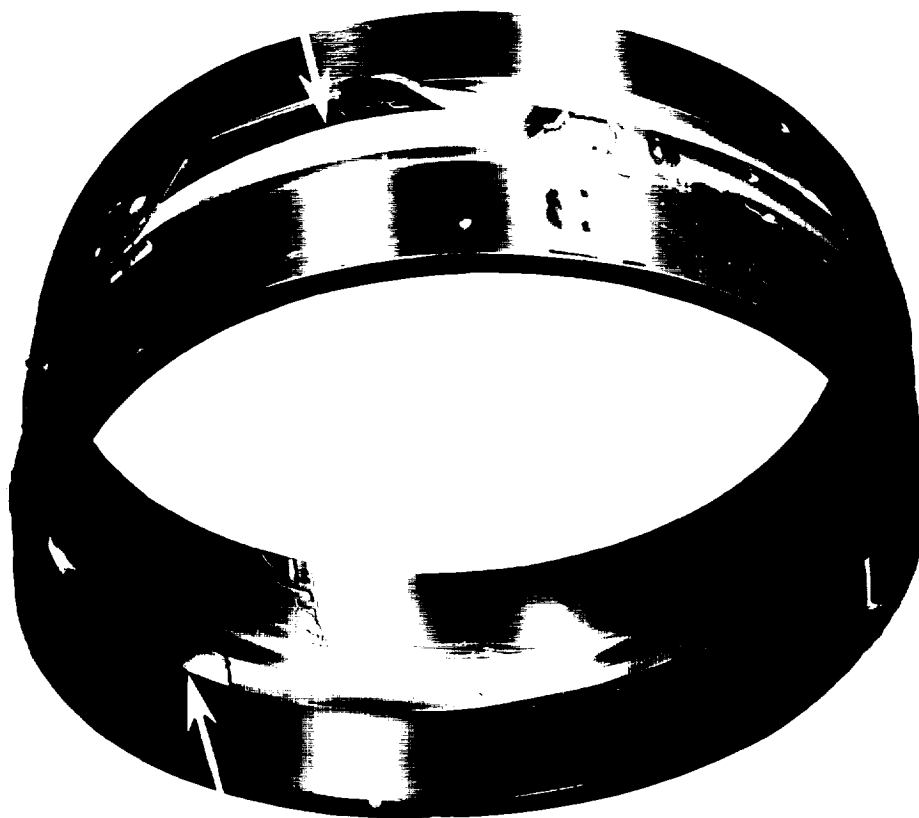
Serrated Edges

POST-TEST NO. 14 CONTAINMENT RING
OPENING "A" DETAIL
